**Flood Control Project Maintenance
Levee Inspections**

Fall 2019 Levee Maintenance Deficiency Summary Report

San Joaquin River Basin

Madera County FCWCA

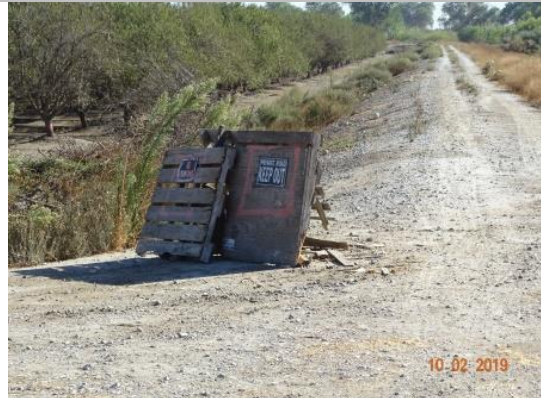
Photo 1 of 2 : FA_2019_NA0011_142_15_20191008_00029.jpg

Pallets used as a sign on levee crown. (Fall 2019)

LM Start	0.02	Rating **	M	Issue No.	15
LM End	0.02	Issue Type +	En	Location *	CR
Category	Earthen Levee			GPS Latitude/Longitude	
				Start	End
Item	Encroachments			37.046524°	37.046524°
				-120.427616°	-120.427616°
DWR ID	DWR_NA0011_01_f_2018_15				
Comment Code					
DE : Debris					
Inspector Comment					
Pallets left on levee crown should be removed.

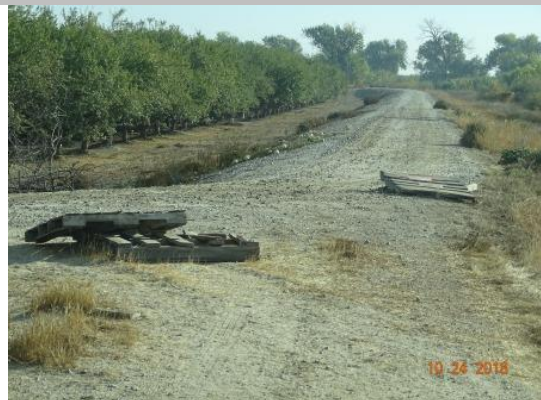
Photo 2 of 2 : FA_2019_NA0011_142_15_20190912_00006.jpg

Pallets left on levee crown. (Fall 2018)

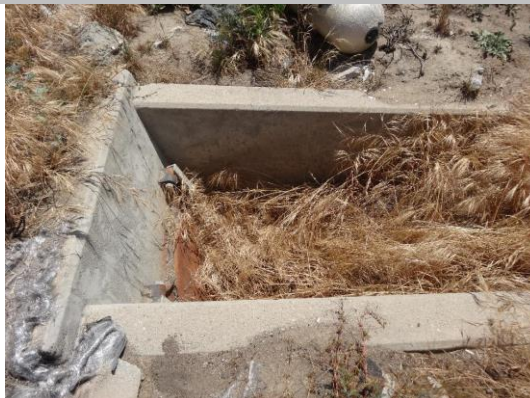
Photo 2 of 3 : UCIP_FA_2019_53153_69673.jpg

DS_ID:21513
FS_ID:53153
EP_NO: N/A
Repair Type: Urgent
Crossing Status: Found
UCIP Comments: 10/31/2018 Erosion present on both the right and the left side of the concrete headwall located on the LS. Pipe inlet is about 50 percent filled with soil. WS outlet is at a low point, water will pond against the levee until it reaches channel elevation. This crossing does not properly drain to the channel. Levee is composed of highly erodible material. Recommend clearing soil from pipe and completing internal pipe inspection to determine pipe integrity through levee. (O. Magana - DWR UCIP)
07/14/2016 No inspection completed--need to inspect October 2016. (DWR UCIP - omagana)05/06/2014 Landward slope has been excavated and a berm built in front of landward headwall. Sediment visible inside pipe from landward side. Dense vegetation limits the inspector's visibility to identify signs of pipe failure (leaks) along the waterward slope. Recommend removing vegetation along pipe alignment and waterward headwall to conduct proper inspection of structure. (DWR UCIP - omagana)

Flap gate located on WS blocked by dense vegetation.

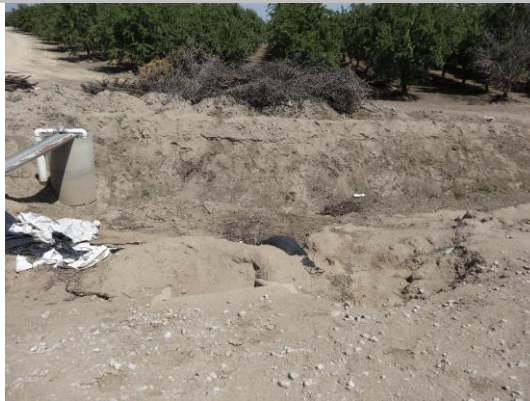
Photo 3 of 3 : UCIP_FA_2019_53153_69675.jpg

View of LS--levee slope has been modified.

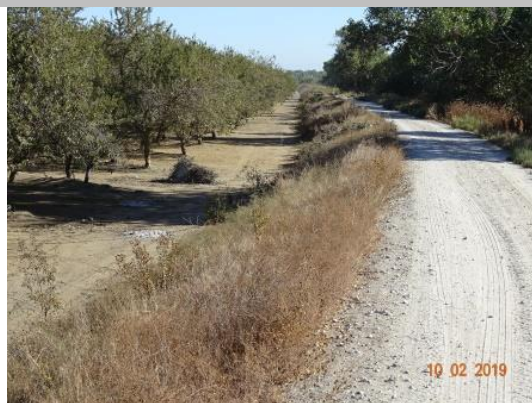
Photo 1 of 1 : FA_2019_NA0011_142_22_20191008_00032.jpg

Looking upstream along the landside slope. (Fall 2019)

LM Start	0.24	Rating **	U	Issue No.	22
LM End	0.80	Issue Type +	Ma	Location *	LS
Category	Earthen Levee			GPS Latitude/Longitude	
				Start	End
Item	Vegetation			37.047492°	37.053543°
				-120.423798°	-120.417370°
DWR ID	DWR_NA0011_01_f_2019_22				
Comment Code					
V1 : Control annual grass and weeds on the levee slopes and easements.					
Inspector Comment

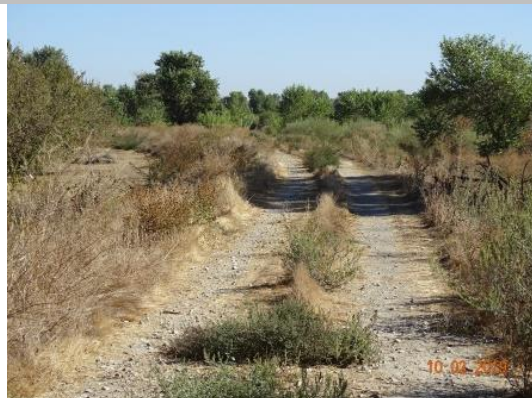
Photo 1 of 1 : FA_2019_NA0011_142_23_20191008_00033.jpg

View along the levee crown looking upstream. (Fall 2019)

LM Start	0.44	Rating **	U	Issue No.	23
LM End	0.80	Issue Type +	Ma	Location *	CR
Category	Earthen Levee			GPS Latitude/Longitude	
				Start	End
Item	Vegetation			37.049450 °	37.053540 °
				-120.421165 °	-120.417372 °
DWR ID	DWR_NA0011_01_f_2019_23				
Comment Code					
V9 : Keep the crown roadway free of vegetation.					
Inspector Comment

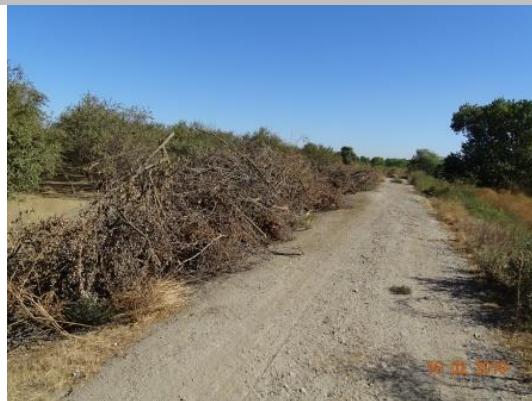
Photo 1 of 3 : FA_2019_NA0011_142_13_20191008_00034.jpg

Large pruning pile left on landside slope. (Fall 2019)

LM Start	0.59	Rating **	U	Issue No.	13
LM End	0.61	Issue Type +	En	Location *	LS
Category	Earthen Levee			GPS Latitude/Longitude	
				Start	End
Item	Encroachments			37.050920 °	37.051093 °
				-120.419210 °	-120.418992 °
DWR ID	DWR_NA0011_01_f_2017_13				
Comment Code					
PR : Prunings					
Inspector Comment					
Remove the large pruning piles on landside slope.

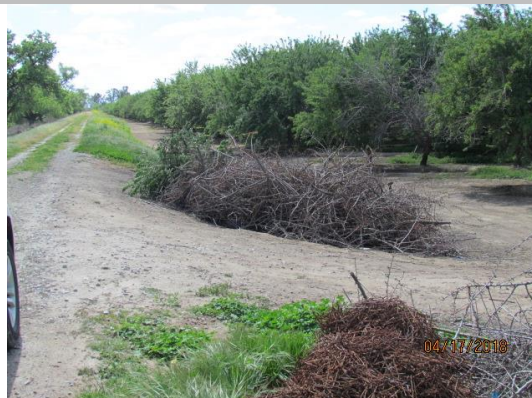
Photo 2 of 3 : FA_2019_NA0011_142_13_20190912_00003.jpg

Looking west at pruning pile on landward slope. (Spring 2018)

LM Start	0.59	Rating **	U	Issue No.	13 (cont)	
LM End	0.61	Issue Type +	En	Location *	LS	
Category	Earthen Levee			GPS Latitude/Longitude		
				Start		End
Item	Encroachments			37.050920 °		37.051093 °
				-120.419210 °		-120.418992 °
DWR ID	DWR_NA0011_01_f_2017_13					
Comment Code						
PR : Prunings						
Inspector Comment						
Remove the large pruning piles on landside slope.

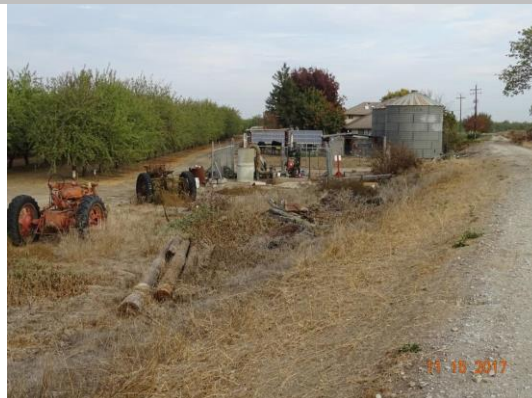
Photo 1 of 1 : FA_2019_NA0011_142_14_20190912_00005.jpg

Farm equipment and debris placed within the easement landside levee toe.

LM Start	0.74	Rating **	U	Issue No.	14
LM End	0.78	Issue Type +	En	Location *	LS
Category	Earthen Levee			GPS Latitude/Longitude	
				Start	End
Item	Encroachments			37.052619 °	37.053238 °
				-120.417726 °	-120.417488 °
DWR ID	DWR_NA0011_01_s_2013_14				
Comment Code					
EQ : Equipment					
Inspector Comment					
Move equipment and debris away from levee to allow inspection and access to landside slope, toe and 10-foot easement.

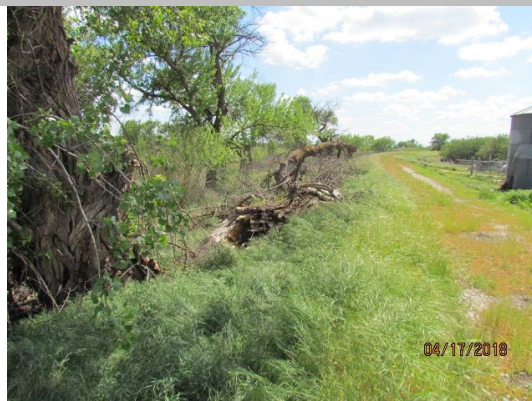
Photo 1 of 1 : FA_2019_NA0011_142_21_20190912_00009.jpg

Looking west at tree limbs and branches on waterward slope. (Spring 2018)

LM Start	0.75	Rating **	U	Issue No.	21
LM End	0.75	Issue Type +	Ma	Location *	WS
Category	Earthen Levee			GPS Latitude/Longitude	
				Start	End
Item	Encroachments			37.052796 °	37.052796 °
				-120.417641 °	-120.417640 °
DWR ID	DWR_NA0011_01_f_2017_21				
Comment Code					
TR : Tree or limb					
Inspector Comment					
Remove tree limbs from waterside slope.

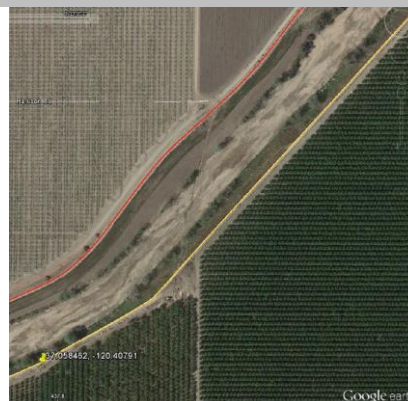
Photo 1 of 3 : UCIP_FA_2019_53155_75206.jpg

UCIP Comments: 10/31/2018 Pipe has been capped off. No integrity issues were observed during the site inspection. Crossing has been downgraded from Urgent to Non-Urgent. Need to coordinate with the CVFPB to determine if the unauthorized crossing will need to be removed, pending issue that needs to be resolved. (O. Magana - DWR UCIP)

06/14/2016 Levee disturbed without prior authorization, it appears that the pipe owner did not notify CVFPB of the construction activity. Crossing was added to UCIP database. Spoke to Herman Phillips (DWR Levee Inspector) regarding unauthorized pipe installation along LS toe of U2. The LS toe of U2 (approximately 731 feet) was disturbed. DWR Inspector mentioned that Dario Dominguez with Madera County Flood Control, LMA representative, has sent the pipe owner notification of unauthorized excavation to replace existing pipe along U2 LS toe, dated May 5, 2016. After reviewing the timed aerial photographs (aerials) under Google Earth a new discovery was made regarding the extend of the area disturbed. Based on the aerials it appears that the new pipe system goes through U1 and U2 levees, across Ash Slough, and along LS toe of U2. The pipe through the levees and channel appears to tie into the work currently being done on the LS toe of U2. Both U1 and U2 levees appear to have been disturbed during 2014-2015. The aerials show that the crossing was not present in the aerial dated 4/5/2014, crossing was not present during the 2014 UCIP Inspection dated 5/6/2014, and the crossing was present in the aerial dated 3/18/2015. According to DWR Inspector, Dario Dominguez with Madera County Flood Control was notified of the additional unauthorized encroachment issue (unauthorized work completed in 2014-2015 on both levees and the channel) that could be related to the trench work being completed by Mr. Sterling. (DWR UCIP - omagana)

Aerial photo of Encroachment visible through levee and channel in 2015.
(Source: Google Earth, 3/18/2015)

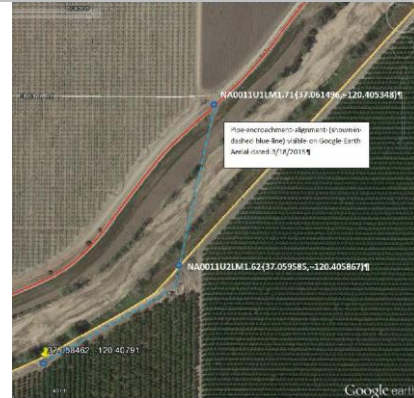
Photo 2 of 3 : UCIP_FA_2019_53155_75221.jpg

FIELD_STRUCT_DESC: *ILLEGAL ENCROACHMENT* 10-inch to 12-inch irrigation siphon pipe of an unknown material through both levees and across the channel, at an unknown depth. The pipe starts on the landside (LS) toe of Unit 1 (U1) and continues across the channel and through the Unit 2 (U2) levee. The pipe then runs along the LS toe of U2 for approximately 731 feet. This crossing was field discovered. The owner of this crossing is Michael Alexander Sterling, 19140 Faralton Road, Madera, CA 93638-0313.
FS Date: 10/31/2018 11:26:00 AM

Assumed alignment of pipe through the levees and along LS toe of U2.
(Source: Google Earth, 3/18/2015)

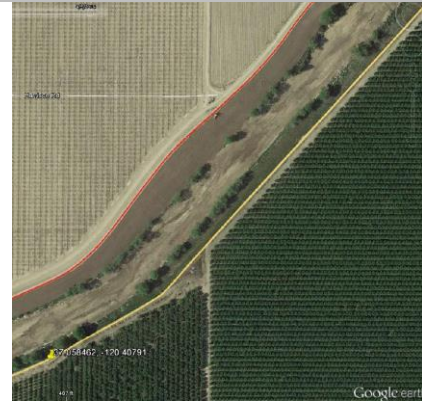
Photo 3 of 3 : UCIP_FA_2019_53155_75207.jpg

UCIP Comments: 10/31/2018 Pipe has been capped off. No integrity issues were observed during the site inspection. Crossing has been downgraded from Urgent to Non-Urgent. Need to coordinate with the CVFPB to determine if the unauthorized crossing will need to be removed, pending issue that needs to be resolved. (O. Magana - DWR UCIP)

Aerial photo of Encroachment not present in 2014. (Source: Google Earth, 4/5/2014)

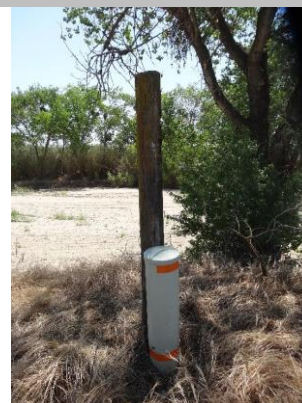
Photo 1 of 1 : UCIP_FA_2019_52846_71806.jpg

LM Start	2.09	Rating **	M	Issue No.	47
LM End	2.09	Issue Type +	En	Location *	
Category	Supplemental			GPS Latitude/Longitude	
				Start	End
Item	DRAFT DWR UCIP Field Study			37.065569 °	37.065569 °
				-120.400752 °	-120.400752 °
DWR ID	21511				
Comment Code					
Inspector Comment					
DS_ID:21511 FS_ID:52846 EP_NO: N/A Repair Type: Non-Urgent Crossing Status: Indicator Found UCIP Comments: 05/06/2014 Need to contact to owner to get contact information. (DWR UCIP - O. Magana) FIELD_STRUCT_DESC: Telephone conduit of an unknown size or material through the levee, at an unknown depth. [Additional Reference(s): DWR Levee Log, 2005]. FS Date: 5/6/2014

Conduit box located on waterward side.

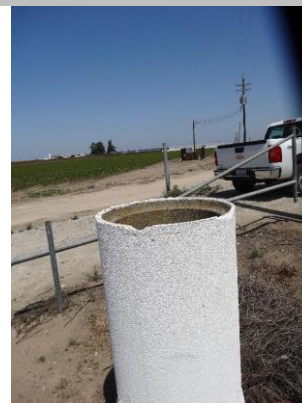
Photo 2 of 3 : UCIP_FA_2019_52847_71803.jpg

Standpipe visible on waterward side.

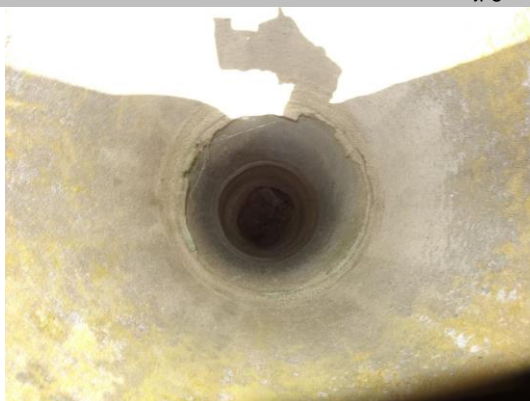
Photo 3 of 3 : UCIP_FA_2019_52847_71804.jpg

LM Start	2.10	Rating **	M	Issue No.	48 (cont)
LM End	2.10	Issue Type +	En	Location *	
Category	Supplemental			GPS Latitude/Longitude	
				Start	End
Item	DRAFT DWR UCIP Field Study			37.065649 °	37.065649 °
				-120.400663 °	-120.400663 °
DWR ID	25042				
Comment Code					
Inspector Comment					
DS_ID:25042 FS_ID:52847 EP_NO: N/A Repair Type: Non-Urgent Crossing Status: Found UCIP Comments: 05/06/2014 Need to contact owner to determine if crossing goes through levee. (DWR UCIP - O. Magana) FIELD_STRUCT_DESC: 10-inch or 12-inch drainage discharge pipe of an unknown material through the levee, at an unknown depth. Crossing visible inside a concrete standpipe on the waterside (WS). Potential pump station on the landside (LS), approximately 100 feet from the standpipe. This crossing was field discovered. FS Date: 5/6/2014

Inside view of concrete standpipe.

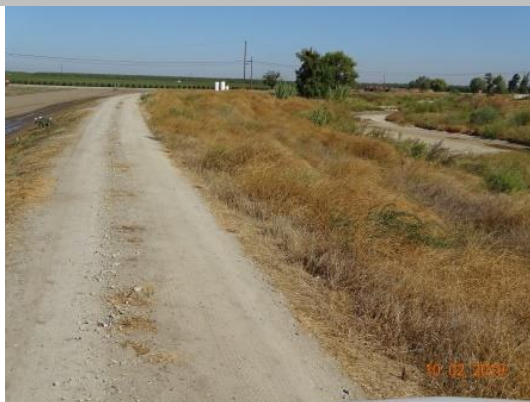
Photo 1 of 1 : FA_2019_NA0011_142_27_20191008_00035.jpg

View of vegetation on the waterside slope looking upstream. (Fall 2019)

LM Start	2.26	Rating **	U	Issue No.	27
LM End	2.35	Issue Type +	Ma	Location *	WS
Category	Earthen Levee			GPS Latitude/Longitude	
				Start	End
Item	Vegetation			37.067192 °	37.068533 °
				-120.398770 °	-120.398663 °
DWR ID	DWR_NA0011_01_f_2019_27				
Comment Code					
V1 : Control annual grass and weeds on the levee slopes and easements.					
Inspector Comment

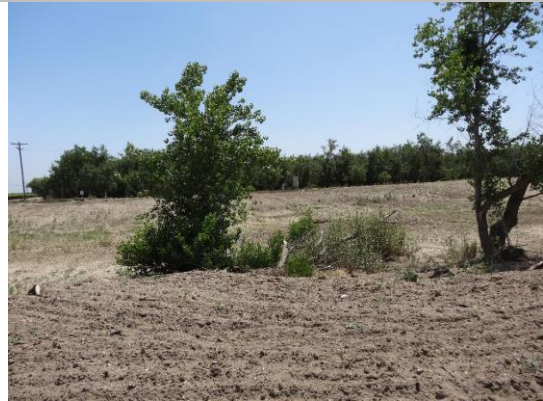
Photo 1 of 3 : UCIP_FA_2019_52848_69679.jpg

LM Start	2.37	Rating **	M	Issue No.	49	
LM End	2.37	Issue Type +	En	Location *		
Category	Supplemental			GPS Latitude/Longitude		
				Start	End	
Item	DRAFT DWR UCIP Field Study			37.068763 °	37.068763 °	
				-120.398523 °	-120.398523 °	
DWR ID	21512					
Comment Code						
Inspector Comment						
DS_ID:21512 FS_ID:52848 EP_NO: N/A Repair Type: Non-Urgent Crossing Status: Found UCIP Comments: 05/06/2014 Unable to determine details of crossing and whether crossing has been abandoned. Need to find owner and determine the alignment of crossing to confirm if pipe is being extended from opposite levee. (DWR UCIP - O. Magana) FIELD_STRUCT_DESC: *ABANDONED* Service pole, pump, and two 36-inch standpipes on the landside (LS). Pump not found during 2014 inspection. Three standpipes found on the LS. [Additional Reference(s): DWR Levee Log, 2005]. FS Date: 5/6/2014

View of waterward side.

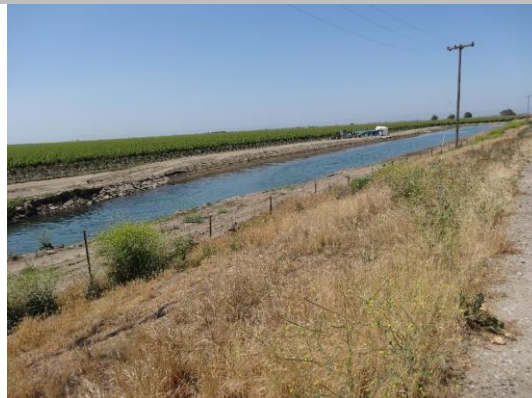
Photo 1 of 3 : UCIP_FA_2019_52830_71662.jpg

View of landward side.

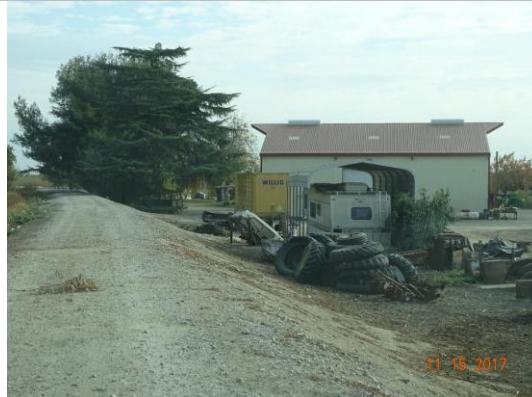
Photo 1 of 1 : FA_2019_NA0011_143_12_20190912_00008.jpg

LM Start	0.09	Rating **	U	Issue No.	12
LM End	0.16	Issue Type +	En	Location *	LS
Category	Earthen Levee			GPS Latitude/Longitude	
				Start	End
Item	Encroachments			37.045876 °	37.046198 °
				-120.425932 °	-120.424737 °
DWR ID	DWR_NA0011_02_f_2017_12				
Comment Code					
EQ : Equipment					
Inspector Comment

Move equipment away from levee slope, toe and 10-foot easement at toe to allow inspection and access.

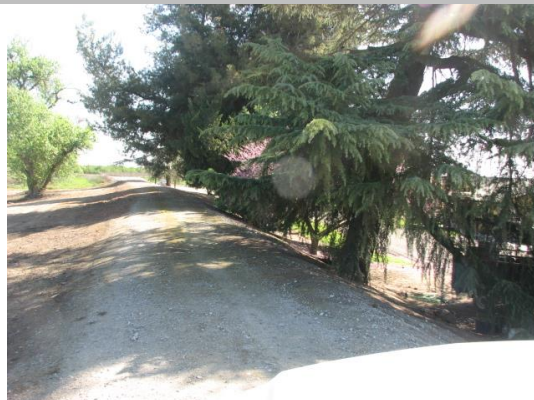
Photo 1 of 1 : FA_2019_NA0011_143_23_20190912_00014.jpg

Looking downstream at tree on landward slope. (Spring 2018)

LM Start	0.16	Rating **	U	Issue No.	23
LM End	0.23	Issue Type +	En	Location *	LS
Category	Earthen Levee			GPS Latitude/Longitude	
				Start	End
Item	Vegetation			37.046240 °	37.046583 °
				-120.424608 °	-120.423560 °
DWR ID	DWR_NA0011_02_s_2017_23				
Comment Code					
V6 : Landscaping					
Inspector Comment					
Trim the tree limbs blocking view of landward levee slope.

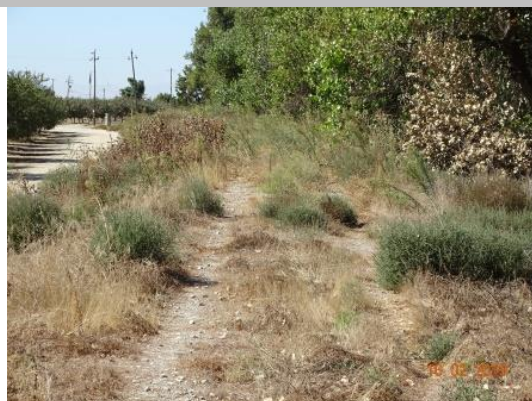
Photo 1 of 1 : FA_2019_NA0011_143_20_20191008_00049.jpg

Looking along the levee crown looking downstream. (Fall 2019)

LM Start	0.29	Rating **	U	Issue No.	20
LM End	0.44	Issue Type +	Ma	Location *	CR
Category	Earthen Levee			GPS Latitude/Longitude	
				Start	End
Item	Vegetation			37.047018 °	37.048545 °
				-120.422535 °	-120.420575 °
DWR ID	DWR_NA0011_02_f_2019_20				
Comment Code					
V9 : Keep the crown roadway free of vegetation.					
Inspector Comment

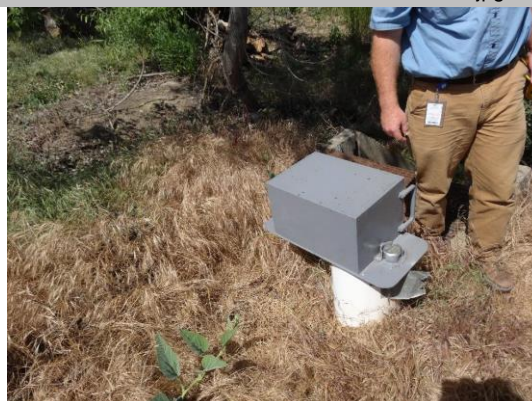
Photo 2 of 3 : UCIP_FA_2019_52834_64466.jpg

LM Start	0.31	Rating **	M	Issue No.	48 (cont)
LM End	0.31	Issue Type +	En	Location *

Locked box (unknown purpose) located on waterward side.

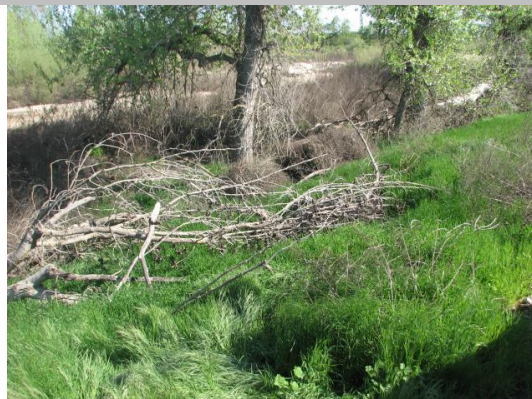
Photo 1 of 1 : FA_2019_NA0011_143_28_20190912_00020.jpg

LM Start	0.32	Rating **	M	Issue No.	28
LM End	0.32	Issue Type +	Ma	Location *	WS
Category	Earthen Levee			GPS Latitude/Longitude	
				Start	End
Item	Encroachments			37.047416 °	37.047416 °
				-120.422142 °	-120.422142 °
DWR ID	DWR_NA0011_02_f_2012_28				
Comment Code					
TR : Tree or limb					
Inspector Comment					
Remove the dead tree limbs from the waterside slope.

Looking downstream at tree limbs on waterward slope and toe. (Spring 2018)

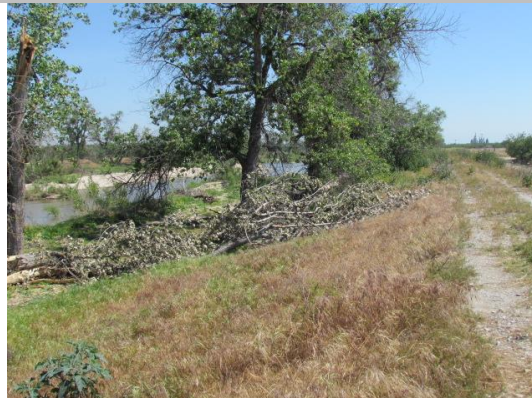
Photo 1 of 1 : FA_2019_NA0011_143_33_20190912_00024.jpg

LM Start	0.33	Rating **	U	Issue No.	33
LM End	0.42	Issue Type +	Ma	Location *	WS
Category	Earthen Levee			GPS Latitude/Longitude	
				Start	End
Item	Encroachments			37.047485 °	37.048403 °
				-120.422037 °	-120.420810 °
DWR ID	DWR_NA0011_02_s_2017_33				
Comment Code					
TR : Tree or limb					
Inspector Comment					
Remove the dead fallen trees from the waterside slope.

Dead fallen trees on the waterside levee slope and shoulder.

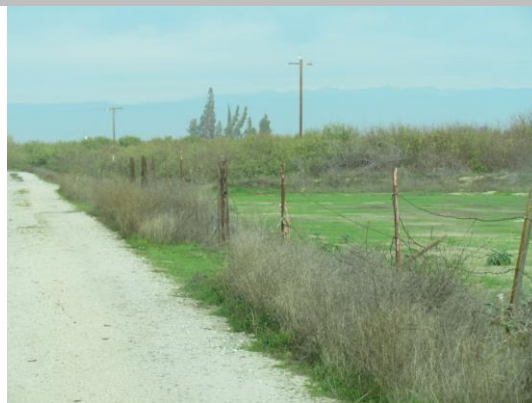
Photo 1 of 1 : FA_2019_NA0011_143_11_20190912_00007.jpg

LM Start	0.45	Rating **	M	Issue No.	11
LM End	0.53	Issue Type +	En	Location *	LS
Category	Earthen Levee			GPS Latitude/Longitude	
				Start	End
Item	Encroachments			37.048627 °	37.049342 °
				-120.420357 °	-120.419370 °
DWR ID	DWR_NA0011_02_s_2012_11				
Comment Code					
FE : Fence					
Inspector Comment					
Wire fence on the landside levee shoulder along with unwanted tall weed growth.

Fence on the landside slope.

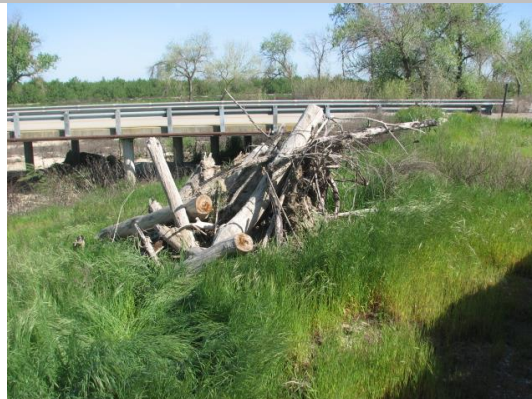
Photo 1 of 1 : FA_2019_NA0011_143_34_20190912_00025.jpg

LM Start	0.93	Rating **	M	Issue No.	34
LM End	0.93	Issue Type +	Ma	Location *	WS
Category	Earthen Levee			GPS Latitude/Longitude	
				Start	End
Item	Encroachments			37.054407 °	37.054407 °
				-120.415928 °	-120.415928 °
DWR ID	DWR_NA0011_02_s_2017_34				
Comment Code					
TR : Tree or limb					
Inspector Comment					
Remove the prunings from the waterside slope.

Looking downstream at bush pile on waterward slope. (Spring 2018)

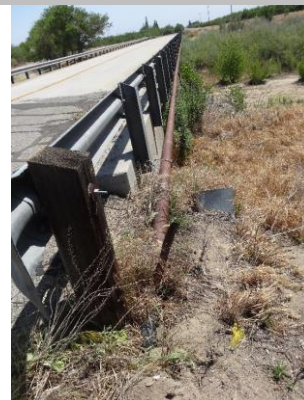
Photo 2 of 3 : UCIP_FA_2019_52839_71822.jpg

LM Start	0.94	Rating **	M	Issue No.	49
LM End	0.94	Issue Type +	En	Location *	
Category	Supplemental			GPS Latitude/Longitude	
				Start	End
Item	DRAFT DWR UCIP Field Study			37.054547°	37.054547°
				-120.415826°	-120.415826°
DWR ID	25043				
Comment Code					
Inspector Comment					
DS_ID:25043 FS_ID:52839 EP_NO: N/A Repair Type: Non-Urgent Crossing Status: Found UCIP Comments: 05/06/2014 Need to contact owner to determine status. Need permit authorizing work. (DWR UCIP - O. Magana) FIELD_STRUCT_DESC: 5-inch steel communications conduit along the downstream face of the bridge. The upstream face has a 2-inch pipe cut at the corner. This crossing was field discovered. FS Date: 5/6/2014

View of steel conduit through levee and above channel.

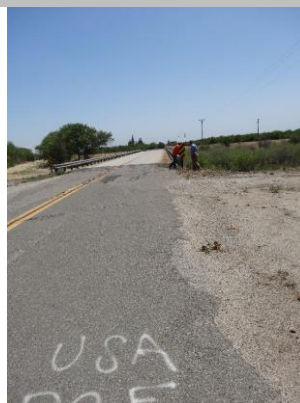
Photo 3 of 3 : UCIP_FA_2019_52839_71821.jpg

LM Start	0.94	Rating **	M	Issue No.	49 (cont)	
LM End	0.94	Issue Type +	En	Location *		
Category	Supplemental			GPS Latitude/Longitude		
				Start	End	
Item	DRAFT DWR UCIP Field Study			37.054547 °	37.054547 °	
				-120.415826 °	-120.415826 °	
DWR ID	25043					
Comment Code						
Inspector Comment						
DS_ID:25043 FS_ID:52839 EP_NO: N/A Repair Type: Non-Urgent Crossing Status: Found UCIP Comments: 05/06/2014 Need to contact owner to determine status. Need permit authorizing work. (DWR UCIP - O. Magana) FIELD_STRUCT_DESC: 5-inch steel communications conduit along the downstream face of the bridge. The upstream face has a 2-inch pipe cut at the corner. This crossing was field discovered. FS Date: 5/6/2014

Overview of bridge.

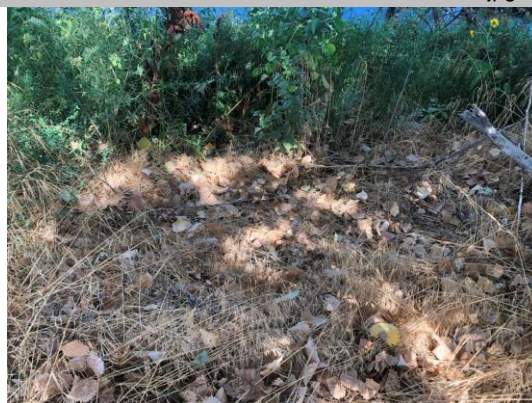
Photo 2 of 3 : SJR2019_NA0011U02RM2.57_1.jpg

Comment Code						
Inspector Comment						
Site ID: NA0011U02RM2.57						
09/10/2019: No significant change observed.						
09/20/2017: No significant change observed.						
07/22/2016: No significant change observed.						
09/08/2015: No significant change observed.						
07/22/2014: No significant change observed.						
08/30/2013: No significant change observed.						
07/31/2012: Site was visited on 07/24/2012. No significant change observed. Dense vegetation around the site						
08/09/2011: Site was inspected. No visible change was observed from the previous condition. A fallen tree was seen at the levee toe about 20 feet upstream, and tree root exposed. There has been no report from the district that this site was corrected.						
11/30/2010: Site was not inspected due to time constraints. There have been no reports from the district that the site was corrected. Continue to monitor site during flood events.

08/05/2010: Recommended for annual assessment and monitoring during flood events, per CLRO.						
2009: Site is recommended as a local maintenance issue, per Critical Levee Repair Office, Critical Erosion Sites Evaluation 2008 Report; site was previously rated "M"						
9/6/2007: Undercutting of the toe; several trees along the WS slope with roots exposed.

Close-up view of the site.

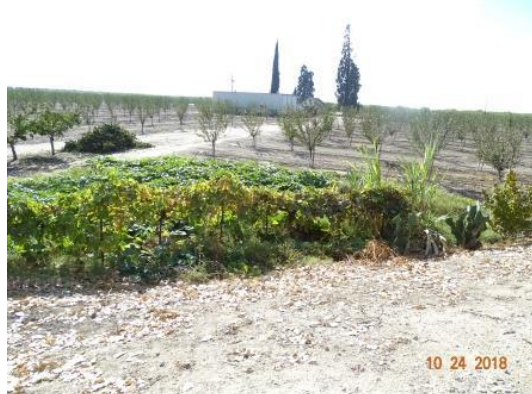
Photo 1 of 3 : FA_2019_NA0011_143_18_20190912_00011.jpg

LM Start	1.24	Rating **	M	Issue No.	18
LM End	1.24	Issue Type +	En	Location *	LS
Category	Earthen Levee			GPS Latitude/Longitude	
				Start	End
Item	Encroachments			37.056226 °	37.056226 °
				-120.411066 °	-120.411066 °
DWR ID	DWR_NA0011_02_f_2017_18				
Comment Code					
LI : Landscape Irrigation					
Inspector Comment					
Landowner removed most of the landscaping except for cactus and grapevines planted at landward toe.

Grapevines, landscaping vegetation, and cactus. (Fall 2018)

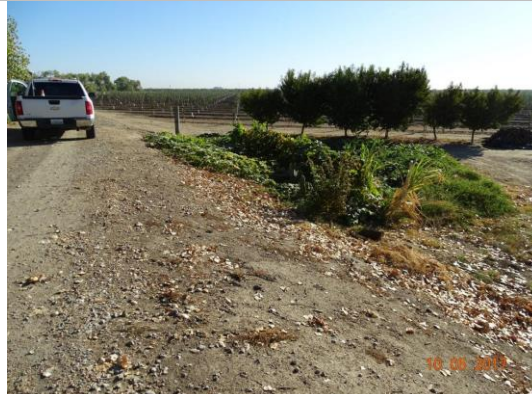
Photo 2 of 3 : FA_2019_NA0011_143_18_20190912_00012.jpg

LM Start	1.24	Rating **	M	Issue No.	18 (cont)
LM End	1.24	Issue Type +	En	Location *	LS

Modify or remove existing landscaping to allow visibility and access.

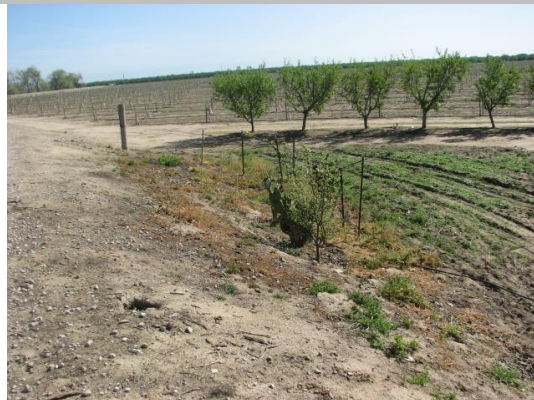
Photo 3 of 3 : FA_2019_NA0011_143_18_20190912_00013.jpg

LM Start	1.24	Rating **	M	Issue No.	18 (cont)	
LM End	1.24	Issue Type +	En	Location *	LS	
Category	Earthen Levee			GPS Latitude/Longitude		
				Start		End
Item	Encroachments			37.056226 °		37.056226 °
				-120.411066 °		-120.411066 °
DWR ID	DWR_NA0011_02_f_2017_18					
Comment Code						
LI : Landscape Irrigation						
Inspector Comment						
Landowner removed most of the landscaping except for cactus and grapevines planted at landward toe.

Looking downstream at cactus on landward toe. (Spring 2018)

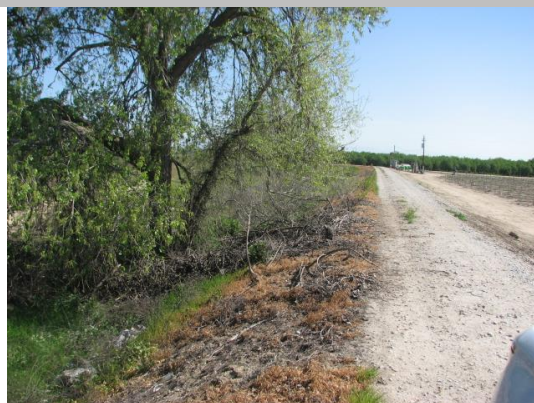
Photo 1 of 1 : FA_2019_NA0011_143_25_20190912_00017.jpg

LM Start	1.51	Rating **	M	Issue No.	25
LM End	1.52	Issue Type +	Ma	Location *	WS
Category	Earthen Levee			GPS Latitude/Longitude	
				Start	End
Item	Trim / Thin Trees			37.058652 °	37.058802 °
				-120.407638 °	-120.407350 °
DWR ID	DWR_NA0011_02_s_2012_25				
Comment Code					
T4 : Trim trees over roadway to at least 12 feet above ground level.					
Inspector Comment					
Trim the trees on the waterside slope levee miles 1.51-1.52.

Looking downstream at untrimmed tree on waterward slope. (Spring 2018)

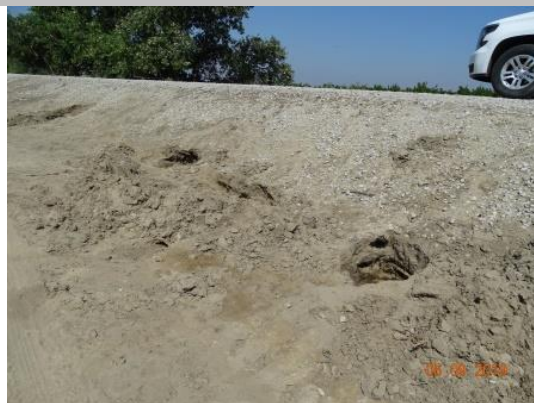
Photo 1 of 2 : FA_2019_NA0011_143_29_20190912_00021.jpg

LM Start	1.52	Rating **	U	Issue No.	29
LM End	1.62	Issue Type +	En	Location *	LS
Category	Earthen Levee			GPS Latitude/Longitude	
				Start	End
Item	Encroachments			37.059016 °	37.058978 °
				-120.406754 °	-120.406847 °
DWR ID	DWR_NA0011_02_f_2018_29				
Comment Code					
LI : Landscape Irrigation					
Inspector Comment					
Irrigation valves set into levee slope and toe.

Digging around valves recently occurred. Appears to be for maintenance of irrigation system. (Spring 2019)

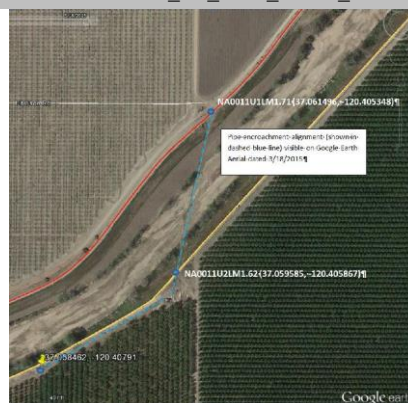
Photo 1 of 3 : UCIP_FA_2019_52842_75220.jpg

UCIP Comments: 7/14/2016 Repair in progress--According to LMA representative, Dario Dominguez, owner has repaired levee slope and compacted material per CVFPB's requirement (compaction tests have been performed). Need to confirm compaction tests were provided to DWR Inspector-Herman Phillips. (DWR UCIP - omagana)6/14/2016 Levee disturbed without prior authorization, it appears that the pipe owner did not notify CVFPB of the construction activity. Crossing was added to UCIP database. Spoke to Herman Phillips (DWR Levee Inspector) regarding unauthorized pipe installation along LS toe of U2. The LS toe of U2 (approximately 731 feet) was disturbed. DWR Inspector mentioned that Dario Dominguez with Madera County Flood Control, LMA representative, has sent the pipe owner notification of unauthorized excavation to replace existing pipe along U2 LS toe, dated May 5, 2016. After reviewing the timed aerial photographs (aerials) under Google Earth a new discovery was made regarding the extend of the area disturbed. Based on the aerials it appears that the new pipe system goes through U1 and U2 levees, across Ash Slough, and along LS toe of U2. The pipe through the levees and channel appears to tie into the work currently being done on the LS toe of U2. Both U1 and U2 levees appear to have been disturbed during 2014-2015. The aerials show that the crossing was not present in the aerial dated 4/5/2014, crossing was not present during the 2014 UCIP Inspection dated 5/6/2014, and the crossing was present in the aerial dated 3/18/2015. According to DWR Inspector, Dario Dominguez with Madera County Flood Control was notified of the additional unauthorized encroachment issue (unauthorized work completed in 2014-2015 on both levees and the channel) that could be related to the trench work being completed by Mr. Sterling. (DWR UCIP - omagana)

Assumed alignment of pipe through the levees and along LS toe of Unit 2. (Source: Google Earth, 3/18/2015)

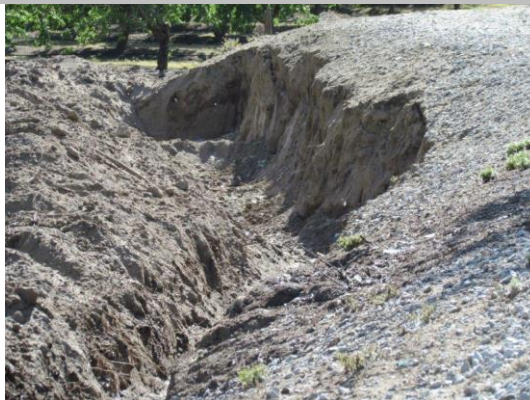
Photo 2 of 3 : UCIP_FA_2019_52842_75227.jpg

UCIP Comments: 7/14/2016 Repair in progress--According to LMA representative, Dario Dominguez, owner has repaired levee slope and compacted material per CVFPB's requirement (compaction tests have been performed). Need to confirm compaction tests were provided to DWR Inspector-Herman Phillips. (DWR UCIP - omagana)6/14/2016 Levee disturbed without prior authorization, it appears that the pipe owner did not notify CVFPB of the construction activity. Crossing was added to UCIP database. Spoke to Herman Phillips (DWR Levee Inspector) regarding unauthorized pipe installation along LS toe of U2. The LS toe of U2 (approximately 731 feet) was disturbed. DWR Inspector mentioned that Dario Dominguez with Madera County Flood Control, LMA representative, has sent the pipe owner notification of unauthorized excavation to replace existing pipe along U2 LS toe, dated May 5, 2016. After reviewing the timed aerial photographs (aerials) under Google Earth a new discovery was made regarding the extend of the area disturbed. Based on the aerials it appears that the new pipe system goes through U1 and U2 levees, across Ash Slough, and along LS toe of U2. The pipe through the levees and channel appears to tie into the work currently being done on the LS toe of U2. Both U1 and U2 levees appear to have been disturbed during 2014-2015. The aerials show that the crossing was not present in the aerial dated 4/5/2014, crossing was not present during the 2014 UCIP Inspection dated 5/6/2014, and the crossing was present in the aerial dated 3/18/2015. According to DWR Inspector, Dario Dominguez with Madera County Flood Control was notified of the additional unauthorized encroachment issue (unauthorized work completed in 2014-2015 on both levees and the channel) that could be related to the trench work being completed by Mr. Sterling. (DWR UCIP - omagana)

View of cut on LS slope of U2 at LM 1.49 (most downstream end of the open trench, photo 1 of 2).

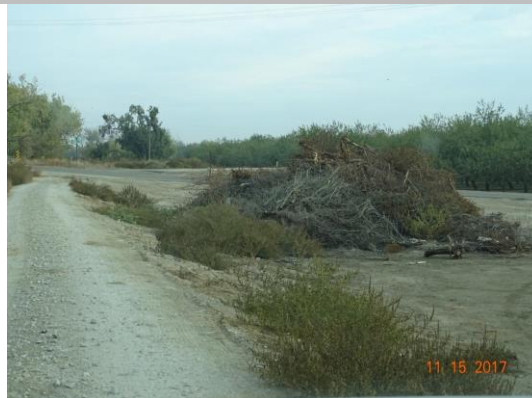
Photo 2 of 2 : FA_2019_NA0011_143_24_20190912_00016.jpg

LM Start	2.00	Rating **	U	Issue No.	24 (cont)	
LM End	2.00	Issue Type +	En	Location *	LS	
Category	Earthen Levee			GPS Latitude/Longitude		
				Start		End
Item	Encroachments			37.063642 °		37.063642 °
				-120.401434 °		-120.401434 °
DWR ID	DWR_NA0011_02_f_2017_24					
Comment Code						
PR : Prunings						
Inspector Comment						
Large pruning/burn pile should be located away from levee toe.

Remove pruning pile to allow inspection and access to landside levee slope and toe.

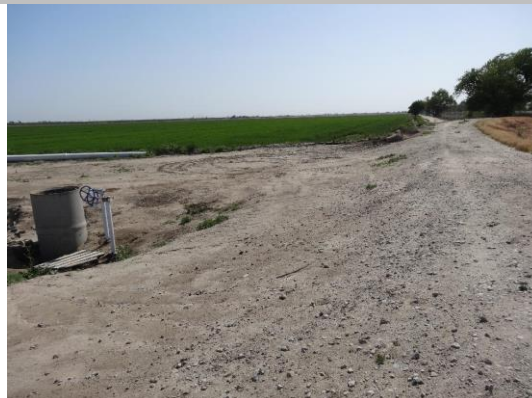
Photo 1 of 3 : UCIP_FA_2019_52829_64476.jpg

View of landward side.

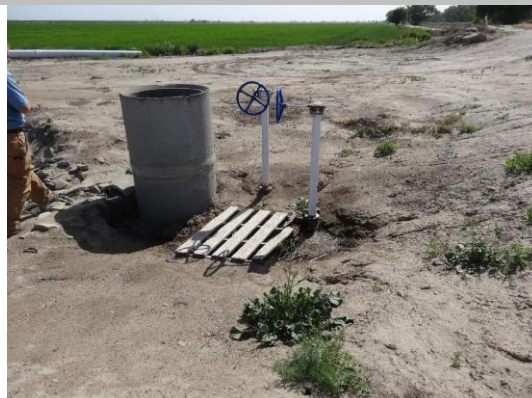
Photo 2 of 3 : UCIP_FA_2019_52829_64475.jpg

Close up of concrete standpipe and multiple positive closure devices.

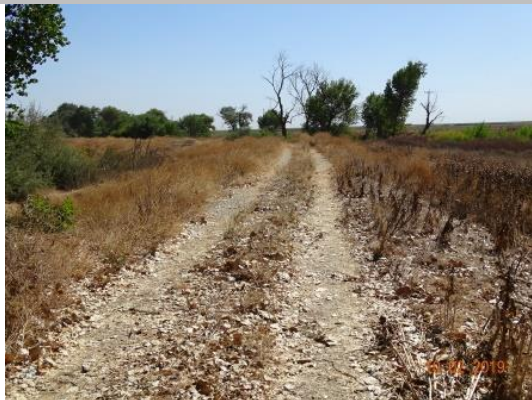
Photo 1 of 2 : FA_2019_NA0011_144_19_20191009_00024.jpg

LM Start	0.04	Rating **	U	Issue No.	19
LM End	1.51	Issue Type +	Ma	Location *	CR
Category	Earthen Levee			GPS Latitude/Longitude	
				Start	End
Item	Vegetation			36.996543 °	36.996602 °
				-120.373043 °	-120.346627 °
DWR ID	DWR_NA0011_03_s_2019_19				
Comment Code					
V9 : Keep the crown roadway free of vegetation.					
Inspector Comment					
Keep the crown roadway free of vegetation.

View along levee crown looking upstream. (Fall 2019)

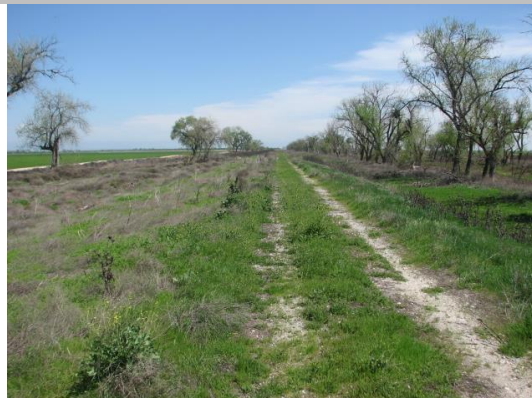
Photo 1 of 1 : FA_2019_NA0011_144_32_20190912_00017.jpg

LM Start	0.08	Rating **	M	Issue No.	32
LM End	1.51	Issue Type +	Ma	Location *	CR
Category	Earthen Levee			GPS Latitude/Longitude	
				Start	End
Item	Crown Surface / Depressions / Rutting			36.996264 °	36.996613 °
				-120.372350 °	-120.346570 °
DWR ID	DWR_NA0011_03_s_2014_32				
Comment Code					
C3 : Add appropriate gravel or road base. Grade and compact.					
Inspector Comment					
Regrade the crown for proper drainage and add more rock to crown.

Looking downstream at levee crown. (Spring 2018)

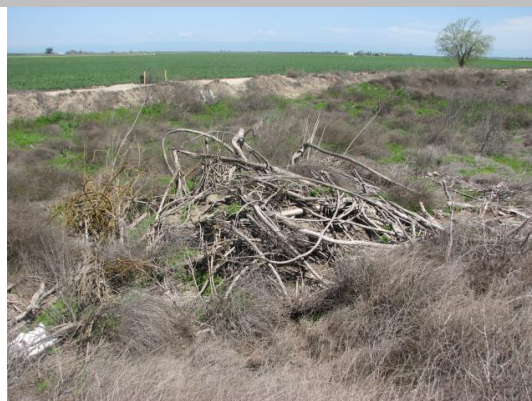
Photo 1 of 1 : FA_2019_NA0011_144_20_20190912_00016.jpg

LM Start	0.08	Rating **	U	Issue No.	20
LM End	0.08	Issue Type +	Ma	Location *	LS
Category	Earthen Levee			GPS Latitude/Longitude	
				Start	End
Item	Encroachments			36.996204 °	36.996201 °
				-120.372352 °	-120.372345 °
DWR ID	DWR_NA0011_03_s_2012_20				
Comment Code					
PR : Prunings					
Inspector Comment					
Remove the prunings from the landside slope.

Looking at prunings on landward slope. (Spring 2018)

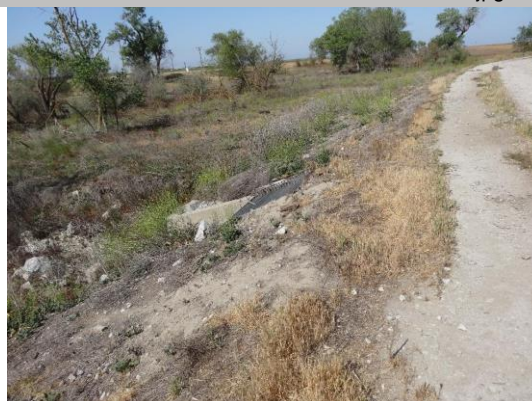
Photo 1 of 3 : UCIP_FA_2019_52832_69689.jpg

View of waterward side.

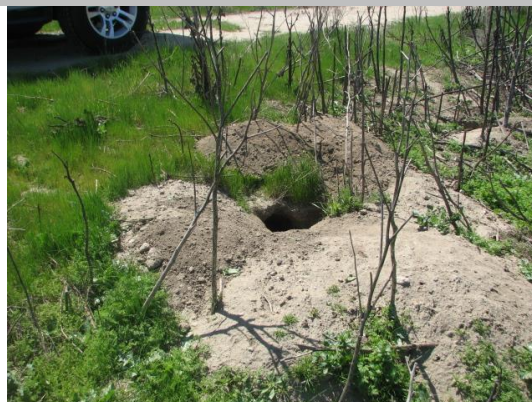
Photo 1 of 6 : FA_2019_NA0011_144_6_20190912_00003.jpg

LM Start	0.40	Rating **	U	Issue No.	6
LM End	1.51	Issue Type +	Ma	Location *	LS
Category	Earthen Levee			GPS Latitude/Longitude	
				Start	End
Item	Animal Control			36.996208 °	36.996607 °
				-120.366550 °	-120.346568 °
DWR ID	DWR_NA0011_03_f_2016_6				
Comment Code					
A1 : Exterminate rodents and backfill and compact or grout burrows.					
Inspector Comment					
LMA should install rodent bait stations placed along the landside slope and/or shoulder at from LM 0.40 to LM 1.51. Unable to see the levee slopes during Spring 2019 inspection however did observe rodents running across the roadway.

Looking at rodent hole on landward slope. (Spring 2018)

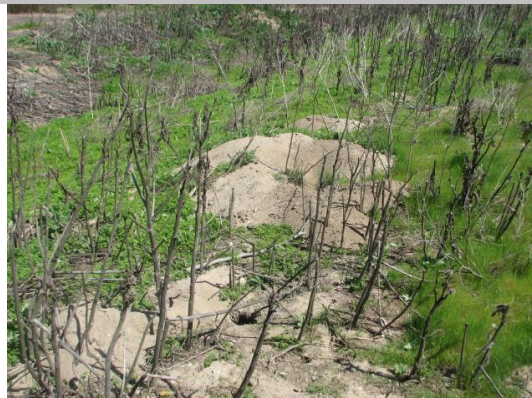
Photo 2 of 6 : FA_2019_NA0011_144_6_20190912_00004.jpg

LM Start	0.40	Rating **	U	Issue No.	6 (cont)
LM End	1.51	Issue Type +	Ma	Location *	LS

Looking at typical rodent holes within this section (Spring 2018)

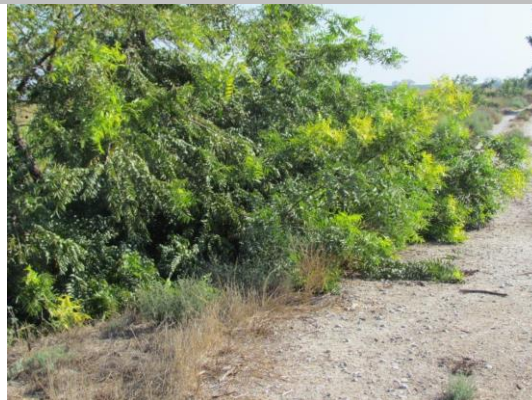
Photo 1 of 1 : FA_2019_NA0011_144_11_20190912_00011.jpg

LM Start	1.04	Rating **	U	Issue No.	11
LM End	1.05	Issue Type +	Ma	Location *	LS
Category	Earthen Levee			GPS Latitude/Longitude	
				Start	End
Item	Trim / Thin Trees			36.996613 °	36.996610 °
				-120.355055 °	-120.354995 °
DWR ID	DWR_NA0011_03_s_2012_11				
Comment Code					
T1 : Trim trees to at least five feet above ground level.					
Inspector Comment					
Remove nut tree from the slope.

Walnut trees blocking the view of the landside levee section.

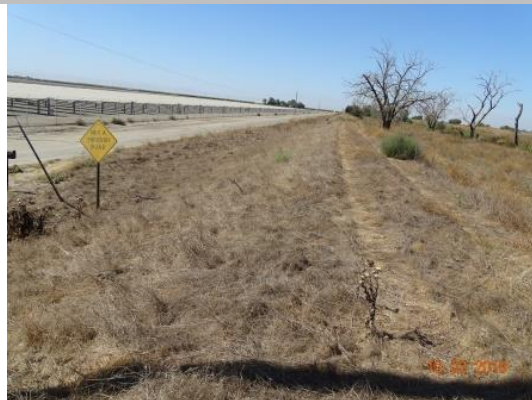
Photo 1 of 2 : FA_2019_NA0011_145_5_20191009_00035.jpg

LM Start	0.02	Rating **	U	Issue No.	5
LM End	1.49	Issue Type +	Ma	Location *	LS
Category	Earthen Levee			GPS Latitude/Longitude	
				Start	End
Item	Vegetation			36.995504 °	36.995582 °
				-120.373233 °	-120.346586 °
DWR ID	DWR_NA0011_04_f_2017_5				
Comment Code					
V1 : Control annual grass and weeds on the levee slopes and easements.					
Inspector Comment

View of vegetation along the landside slope looking downstream. (Fall 2019)

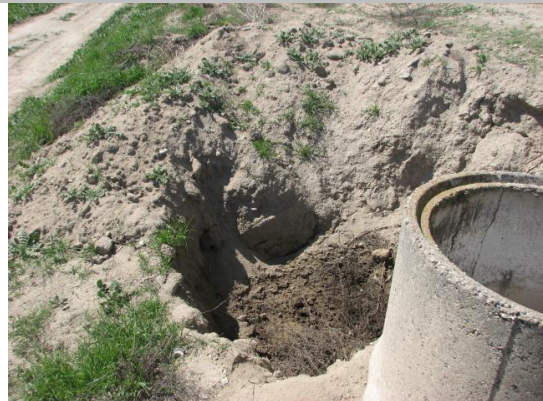
Photo 2 of 3 : FA_2019_NA0011_145_22_20190912_00022.jpg

LM Start	0.44	Rating **	U	Issue No.	22
LM End	0.44	Issue Type +	Ma	Location *	LS
Category	Earthen Levee			GPS Latitude/Longitude	
				Start	End
Item	Erosion / Bank Caving			36.995560 °	36.995560 °
				-120.365614 °	-120.365614 °
DWR ID	DWR_NA0011_04_s_2018_22				
Comment Code					
E2 : Schedule repair of erosion site prior to the next inspection.					
Inspector Comment					
Someone dug a large hole on the landward slope next to the concrete riser. There is no visible pipe at the site.

Looking upstream at large hole on landward slope. (Spring 2018)

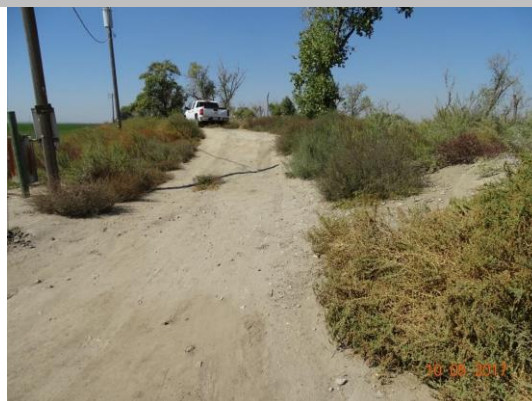
Photo 1 of 2 : FA_2019_NA0011_145_13_20190912_00013.jpg

LM Start	0.94	Rating **	M	Issue No.	13
LM End	0.94	Issue Type +	En	Location *	LS
Category	Earthen Levee			GPS Latitude/Longitude	
				Start	End
Item	Encroachments			36.995571 °	36.995571 °
				-120.356609 °	-120.356609 °
DWR ID	DWR_NA0011_04_f_2017_13				
Comment Code					
RA : Ramp					
Inspector Comment					
There is no permit for the ramp on the landside slope.

Unpermitted ramp on LS slope.

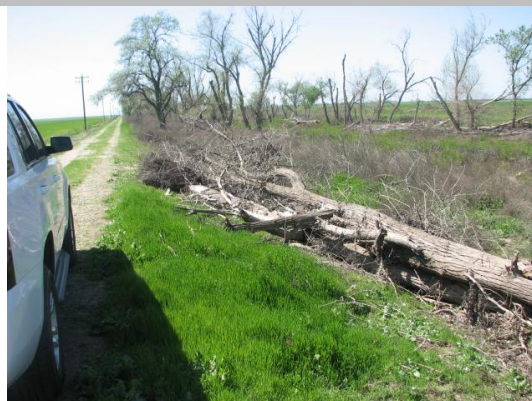
Photo 1 of 1 : FA_2019_NA0011_145_14_20190912_00015.jpg

LM Start	0.94	Rating **	M	Issue No.	14
LM End	0.94	Issue Type +	Ma	Location *	WS
Category	Earthen Levee			GPS Latitude/Longitude	
				Start	End
Item	Encroachments			36.995573 °	36.995573 °
				-120.356601 °	-120.356601 °
DWR ID	DWR_NA0011_04_f_2017_14				
Comment Code					
TR : Tree or limb					
Inspector Comment					
Remove the downed tree from the waterside slope.

Looking upstream at fallen tree on waterward slope. (Spring 2018)

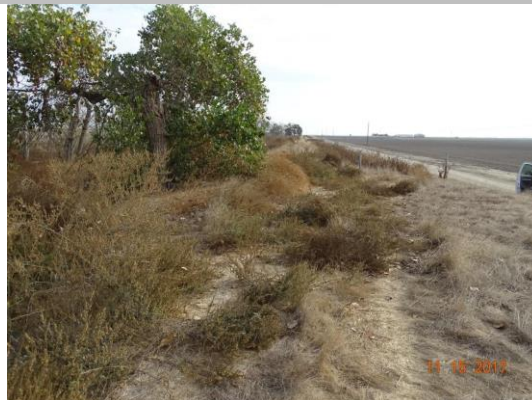
Photo 1 of 1 : FA_2019_NA0011_145_12_20190912_00012.jpg

LM Start	1.01	Rating **	U	Issue No.	12
LM End	1.01	Issue Type +	Ma	Location *	WS
Category	Earthen Levee			GPS Latitude/Longitude	
				Start	End
Item	Trim / Thin Trees			36.995537 °	36.995537 °
				-120.355261 °	-120.355261 °
DWR ID	DWR_NA0011_04_f_2017_12				
Comment Code					
T1 : Trim trees to at least five feet above ground level.					
Inspector Comment					
Branches from waterside tree are blocking visibility of waterside slope and crown. Levee crown is nearly impassible.

Trim trees to at least 5' above levee slope and 12' above levee crown to allow inspection and access.

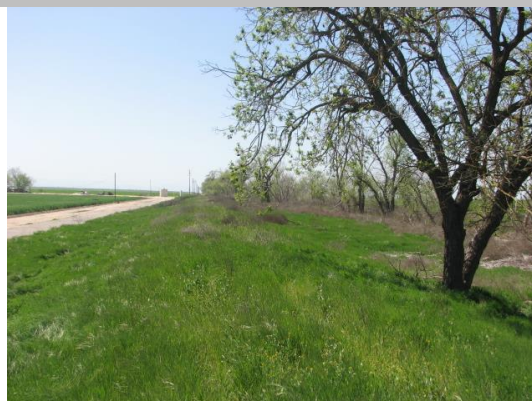
Photo 1 of 1 : FA_2019_NA0011_145_10_20190912_00009.jpg

LM Start	1.19	Rating **	M	Issue No.	10
LM End	1.19	Issue Type +	Ma	Location *	WS
Category	Earthen Levee			GPS Latitude/Longitude	
				Start	End
Item	Trim / Thin Trees			36.995566°	36.995566°
				-120.352038°	-120.352038°
DWR ID	DWR_NA0011_04_f_2017_10				
Comment Code					
T4 : Trim trees over roadway to at least 12 feet above ground level.					
Inspector Comment

Looking upstream at tree on waterward slope. (Spring 2018)

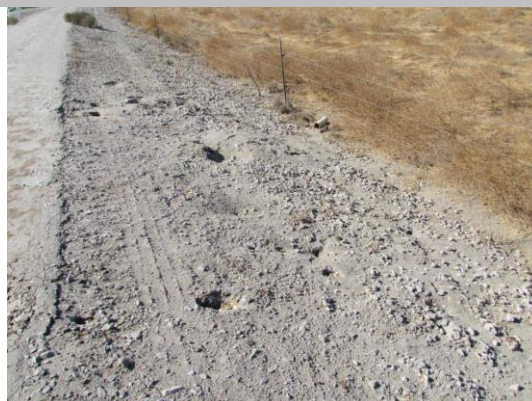
Photo 2 of 2 : FA_2019_NA0011_145_30_20190912_00026.jpg

LM Start	1.50	Rating **	U	Issue No.	30 (cont)
LM End	2.28	Issue Type +	Ma	Location *	WS
Category	Earthen Levee			GPS Latitude/Longitude	
				Start	End
Item	Animal Control			36.995590 °	37.003740 °
				-120.346406 °	-120.336877 °
DWR ID	DWR_NA0011_04_f_2014_30				
Comment Code					
A1 : Exterminate rodents and backfill and compact or grout burrows.					
Inspector Comment					
Bait stations are needed in the rodent infested area on the waterside slope and toe.

View of rodent holes on the waterside slope.

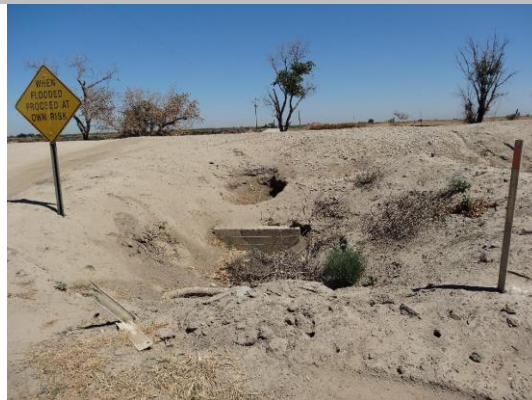
Photo 2 of 3 : UCIP_FA_2019_53154_75761.jpg

Comment Code						
Inspector Comment						
DS_ID:25469 FS_ID:53154 EP_NO: N/A Repair Type: Urgent Crossing Status: Found UCIP Comments: 10/31/2018 Same as last inspection with the exception of the size of the sink hole. Sink hole on LS slope has increased. Levee at this crossing is composed of highly erodible material. Need to coordinate with the pipe owner to determine repair status. Crossing remains Urgent due to the large sink hole present on the LS. (O. Magana - DWR UCIP) 07/14/2016 New entry added--pipe failure. Sink hole present on LS slope. Concrete headwall collapse visible on LS slope. Pipe buried on both WS and LS. (DWR UCIP - omagana) FIELD_STRUCT_DESC: 24-inch (estimate measurement based on flap gate frame) gravity drainage pipe of an unknown material through the levee, approximately 5 feet below the crown. Concrete headwall on the landside (LS). Corrugated metal pipe (CMP) at the LS toe. Sluice gate on the waterside (WS). This crossing was field discovered. FS Date: 10/31/2018 10:19:00 AM

Sink hole and concrete headwall damage is visible on LS.

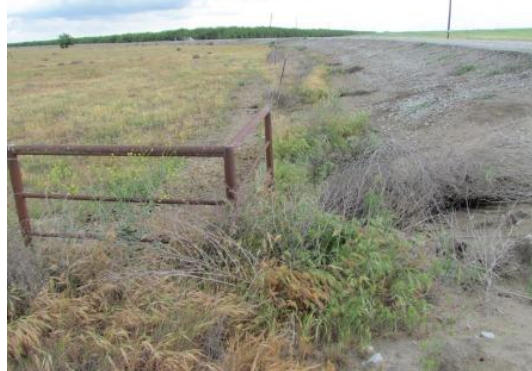
Photo 1 of 1 : FA_2019_NA0011_145_56_20190912_00029.jpg

LM Start	1.51	Rating **	M	Issue No.	56
LM End	2.28	Issue Type +	En	Location *	WS
Category	Earthen Levee			GPS Latitude/Longitude	
				Start	End
Item	Encroachments			36.995615 °	37.003441 °
				-120.346296 °	-121.337349 °
DWR ID	DWR_NA0011_04_s_2012_56				
Comment Code					
FE : Fence					
Inspector Comment

Fence within the 10-foot of levee toe. This encroachment was recorded on 11-01-2012. Photo was taken 4-24-2014.

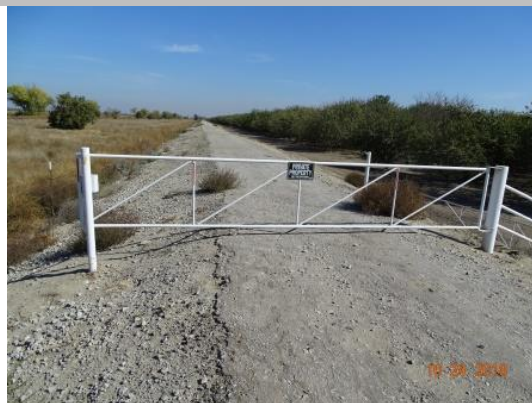
Photo 1 of 1 : FA_2019_NA0011_145_17_20190912_00018.jpg

LM Start	1.60	Rating **	M	Issue No.	17
LM End	1.60	Issue Type +	En	Location *	CR
Category	Earthen Levee			GPS Latitude/Longitude	
				Start	End
Item	Encroachments			36.996212 °	36.996212 °
				-120.344756 °	-120.344756 °
DWR ID	DWR_NA0011_04_f_2018_17				
Comment Code					
FE : Fence					
Inspector Comment					
Gate with combo lock. No permit associated with gate.

Gate blocking access to levee. (Fall 2018)

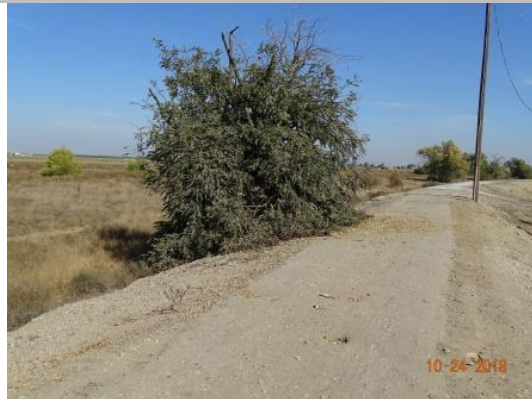
Photo 1 of 1 : FA_2019_NA0011_145_27_20190912_00024.jpg

LM Start	2.22	Rating **	M	Issue No.	27
LM End	2.22	Issue Type +	Ma	Location *	WS
Category	Earthen Levee			GPS Latitude/Longitude	
				Start	End
Item	Trim / Thin Trees			37.003160 °	37.003160 °
				-120.337747 °	-120.337747 °
DWR ID	DWR_NA0011_04_f_2018_27				
Comment Code					
T1 : Trim trees to at least five feet above ground level.					
Inspector Comment					
Trim tree back away from crown and at least 5 feet above the levee slope.

Trim tree on waterside shoulder. (Fall 2018)

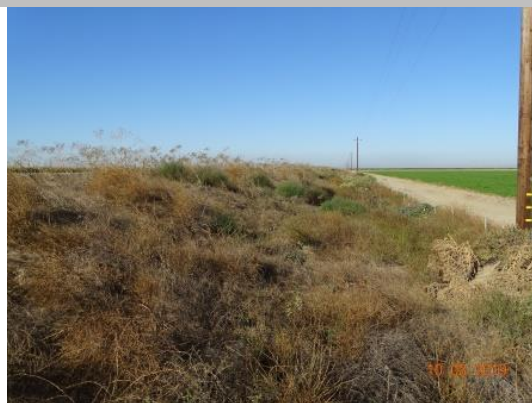
Photo 2 of 2 : FA_2019_NA0011_146_7_20191009_00035.jpg

LM Start	0.01	Rating **	U	Issue No.	7 (cont)	
LM End	4.06	Issue Type +	Ma	Location *	LS	
Category	Earthen Levee			GPS Latitude/Longitude		
				Start		End
Item	Vegetation			36.978438 °	36.968155 °	
				-120.368405 °	-120.300968 °	
DWR ID	DWR_NA0011_05_f_2019_7					
Comment Code						
V1 : Control annual grass and weeds on the levee slopes and easements.						
Inspector Comment

Looking downstream along the landside slope at LM 4.06. (Fall 2019)

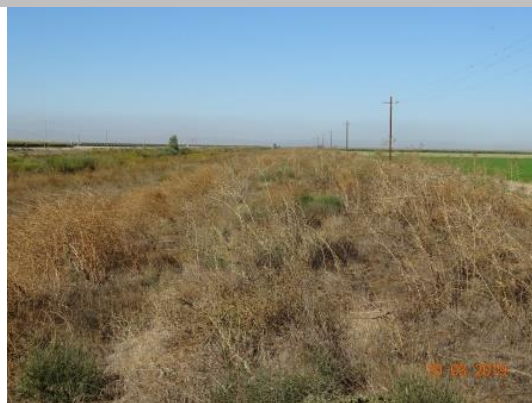
Photo 1 of 2 : FA_2019_NA0011_146_42_20191009_00038.jpg

LM Start	0.04	Rating **	U	Issue No.	42
LM End	4.06	Issue Type +	Ma	Location *	CR
Category	Earthen Levee			GPS Latitude/Longitude	
				Start	End
Item	Vegetation			36.978511 °	36.968173 °
				-120.367758 °	-120.300901 °
DWR ID	DWR_NA0011_05_s_2019_42				
Comment Code					
V9 : Keep the crown roadway free of vegetation.					
Inspector Comment

Looking downstream along levee crown. (Fall 2019)
